# SEQUOYAH LAKE SPILLWAY AND DAM ASSESSMENT

Cherokee Village Suburban Improvement District No.1  
Cherokee Village, Arkansas

November 2025

Olsson Project No. 025-00244

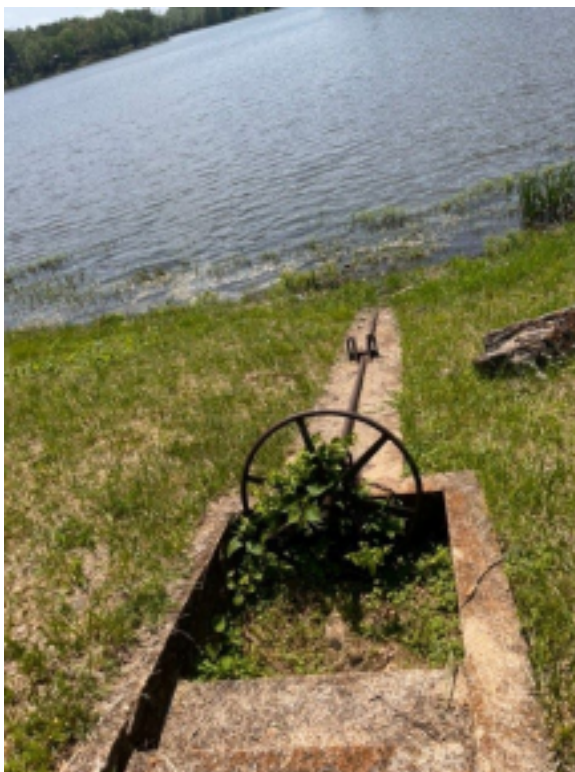
**Figure 1: Lake Navajo Dam Outlet Valve**

- a) The outlet valve requires testing to ensure it is operational (Figure 1).
- b) The downstream slope has excessive brushes and 1” to 2” diameter vegetation (Figure 2), it is recommended to clear the stream and extract the roots of the thick vegetation.
- c) Seepage was noticed at the left side of the dam toe; it is recommended to monitor the seepage. It was also noticed that there is leakage through the dam outlet (Figure 3).

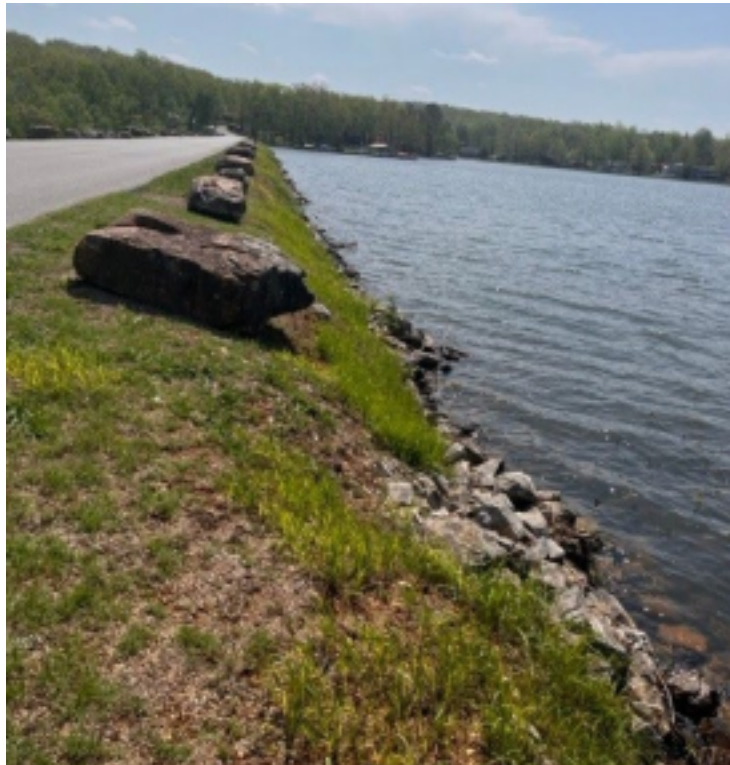
**Figure 4: Sequoyah Lake Dam Upstream**

- a) Minor erosion on the upstream slope, causing misalignment (Figure 4). The slope should be regraded so that it is uniform, and riprap should be added to prevent future erosion.
- b) The outlet valve requires testing to ensure it is operational.
- c) Seepage was noticed at the left side of the dam toe; it is recommended to monitor the seepage. It was also noticed that there is leakage through the dam outlet (Figure 5).
- d) The

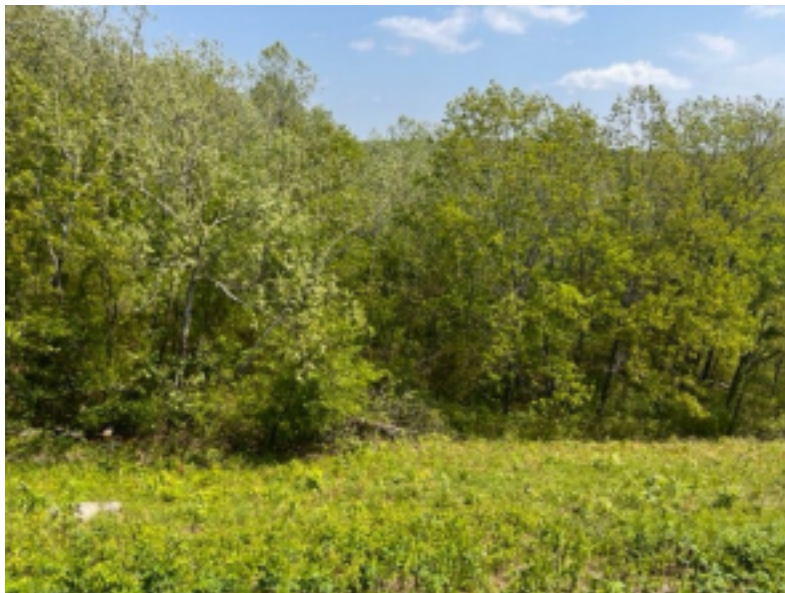
**Figure 5: Sequoyah Lake Dam Seepage**

outlet concrete has some cracks, it is recommended to repair the concrete.

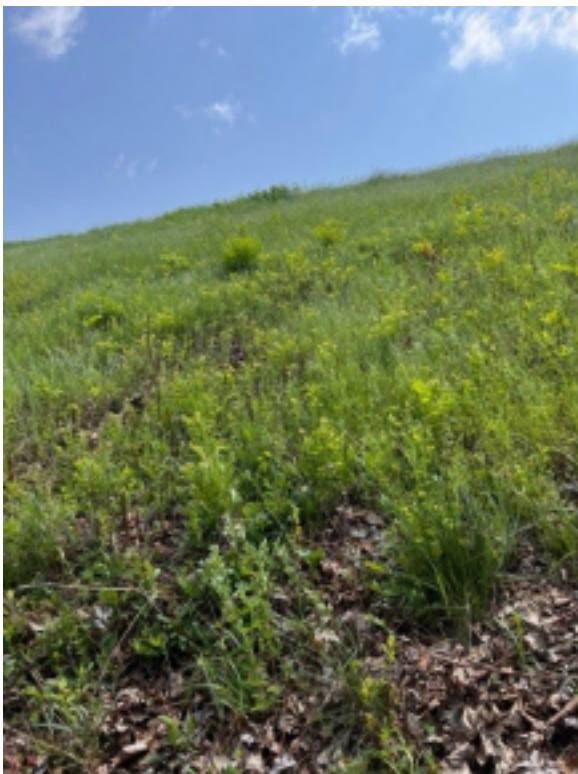
**Figure 6: Cherokee Dam Downstream**

The Cherokee Lake Dam appeared to be in good condition, however, it is recommended to remove the brushes on the downstream and test the spillway gate (Figure 6 and 7).
